SERVICE DEPARTMENT
DODGE DIVISION
CHRYSLER CORPORATION

TECH-NEK TOPICS

VOL 2 NO 1

JANUARY AND FEBRUARY 1957

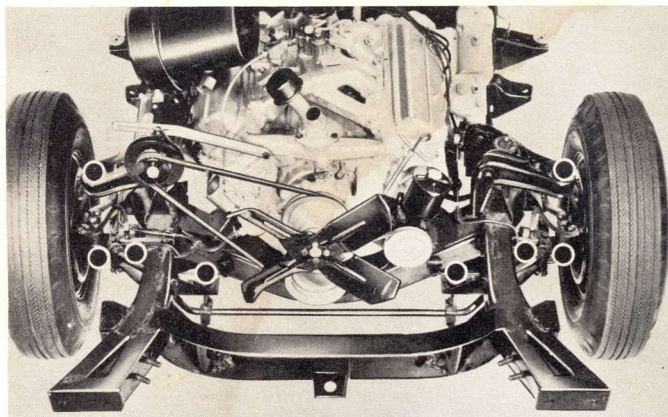
Figure 1

The lubrication points for the front suspension including the steering linkages have been reduced from 23 on the 8 cylinder models and 20 on the 6 cylinder models to 8 on all the "K" series models. Referring to Figure 1, these points are located at the ball joints at the ends of the four control arms. The other four lubrication points are located at each end of the two tie rods. These

zerk fittings should be lubricated every 1,000 miles or 30 days. Rubber bushings should never be lubricated since they are designed to grip the contacting metal parts firmly and operate as a flexible medium between these parts. The use of any lubricant will destroy the necessary friction and cause noise and premature failure of the rubber parts.
